**Stage IB
Cultural Resources Survey
National Smelting of New Jersey Property
Oldmans Township, Salem County,
New Jersey**

February 1993

**Richard Grubb & Associates, Inc.
Cultural Resource Consultants**

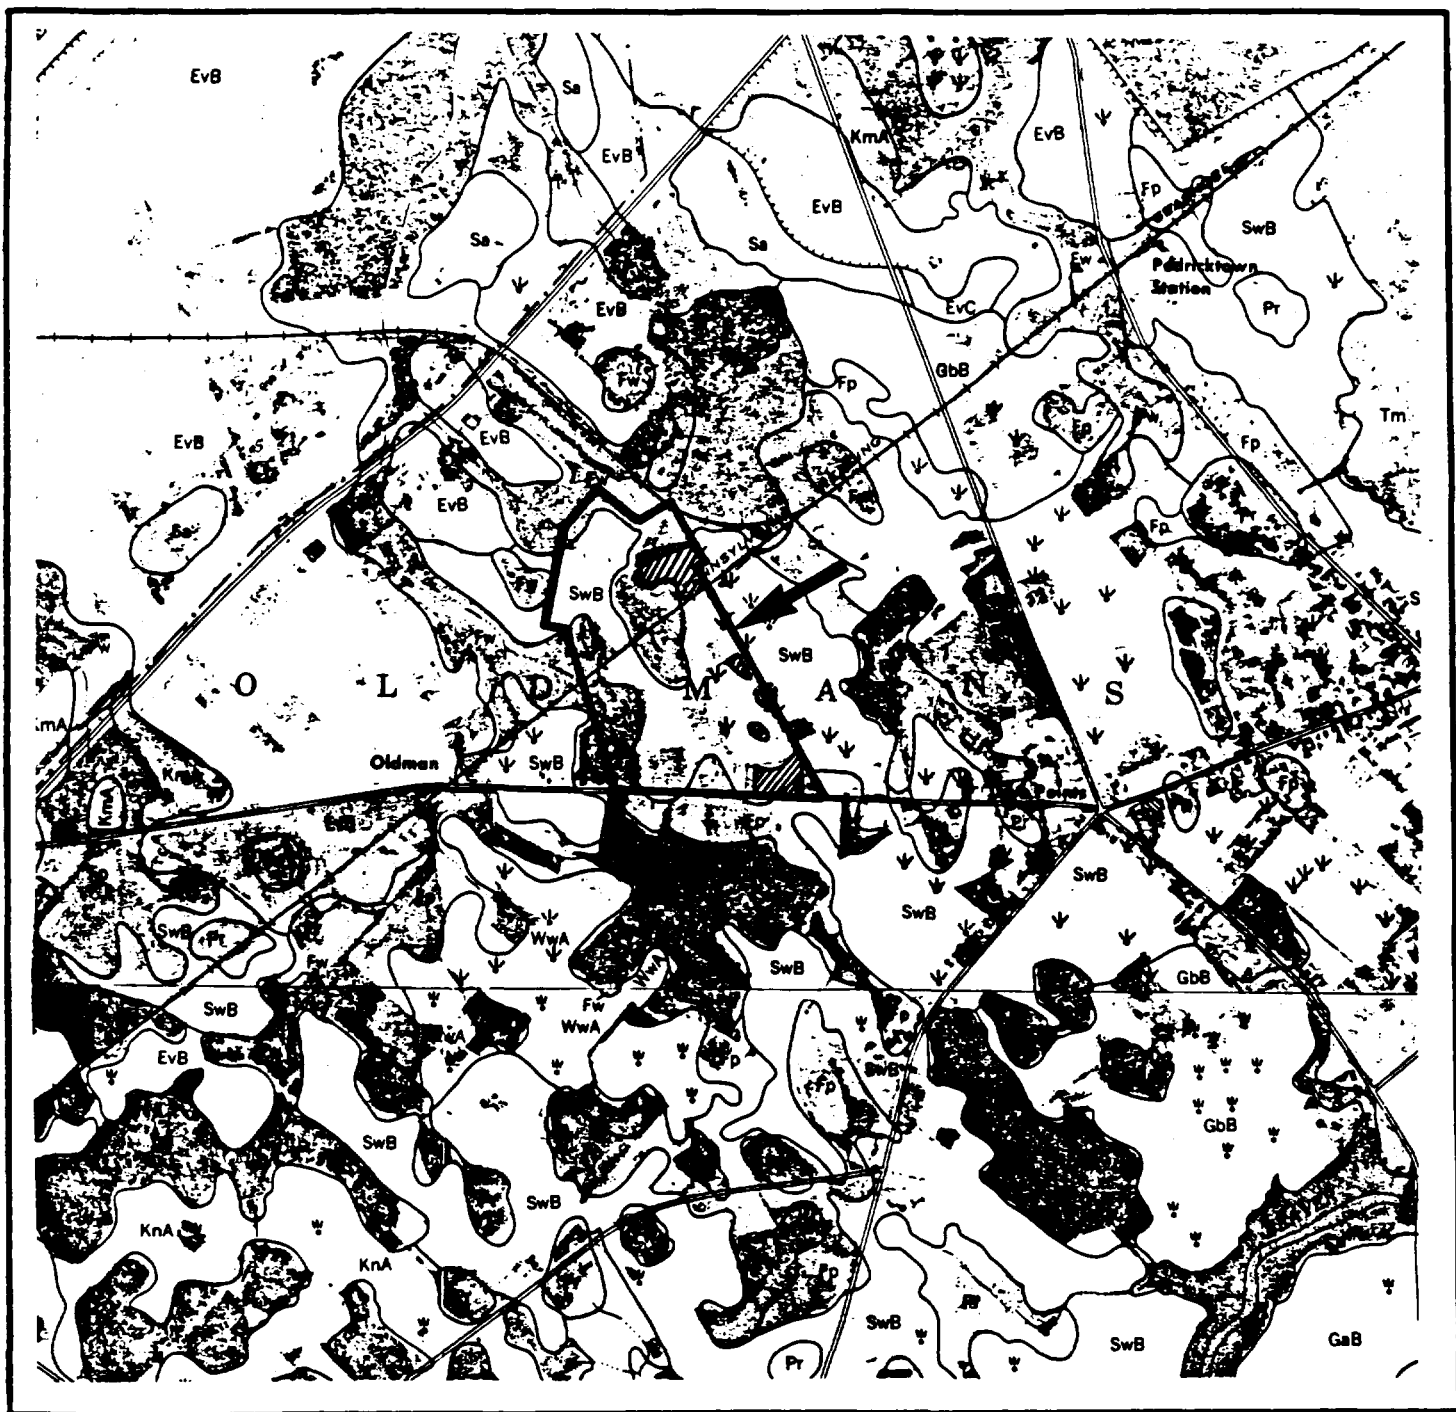
Figure 3:

Soil Survey of Salem County, Sheet Numbers 1 and 2. Arrow indicates the NSNJ property boundary. Hatched lines indicate the four areas of archaeological sensitivity.

Soil profiles revealed during the course of this survey were generally consistent with the Sassafras-Galestown-Woodstown loamy sands indicted in the county soil survey (Powley 1969) (Figure 3).

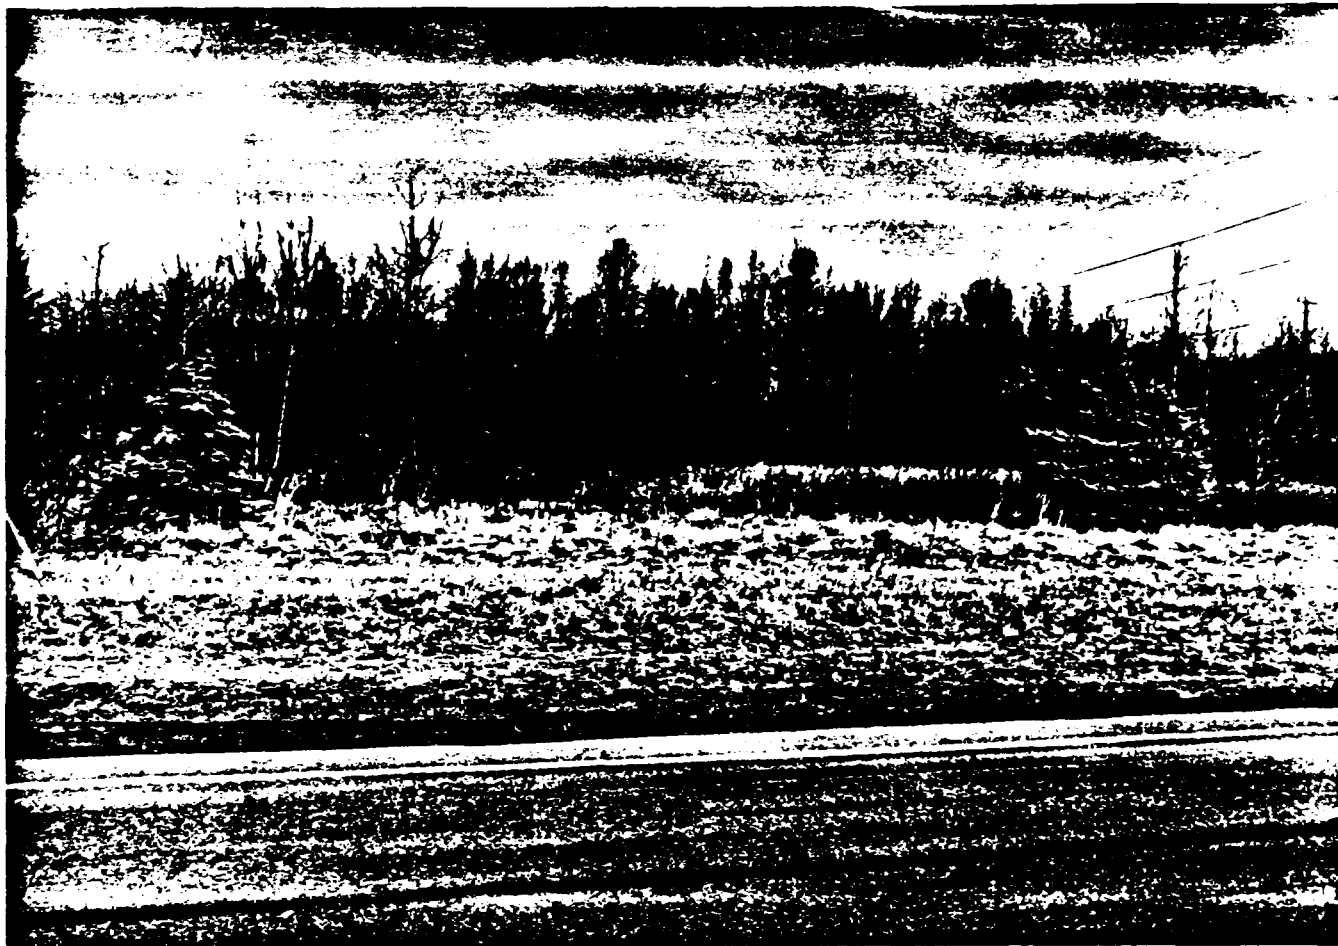
Photo Plate 1:

View looking north at Area 1 from south side of Pennsgrove-
Pedrickstown Road.

Area 1 is located near the southeastern corner of the project parcel (Photo Plates 1 and 2). The area comprises approximately 40,500 square feet (.90 acres), and is roughly bounded by the Pennsgrove-Pedricktown Road on the south, wetlands and the edge of the parcel on the east, wetlands on the north, and a paved parking lot on the west (see base map in back pocket). A portion of this area was formerly used as a gravel parking lot (Stephen W. Holt, January 1993, personal communication). Disturbance within the area consisted of ditches at the margins, a series of test wells near the eastern edge, and impacts associated with the parking lot.

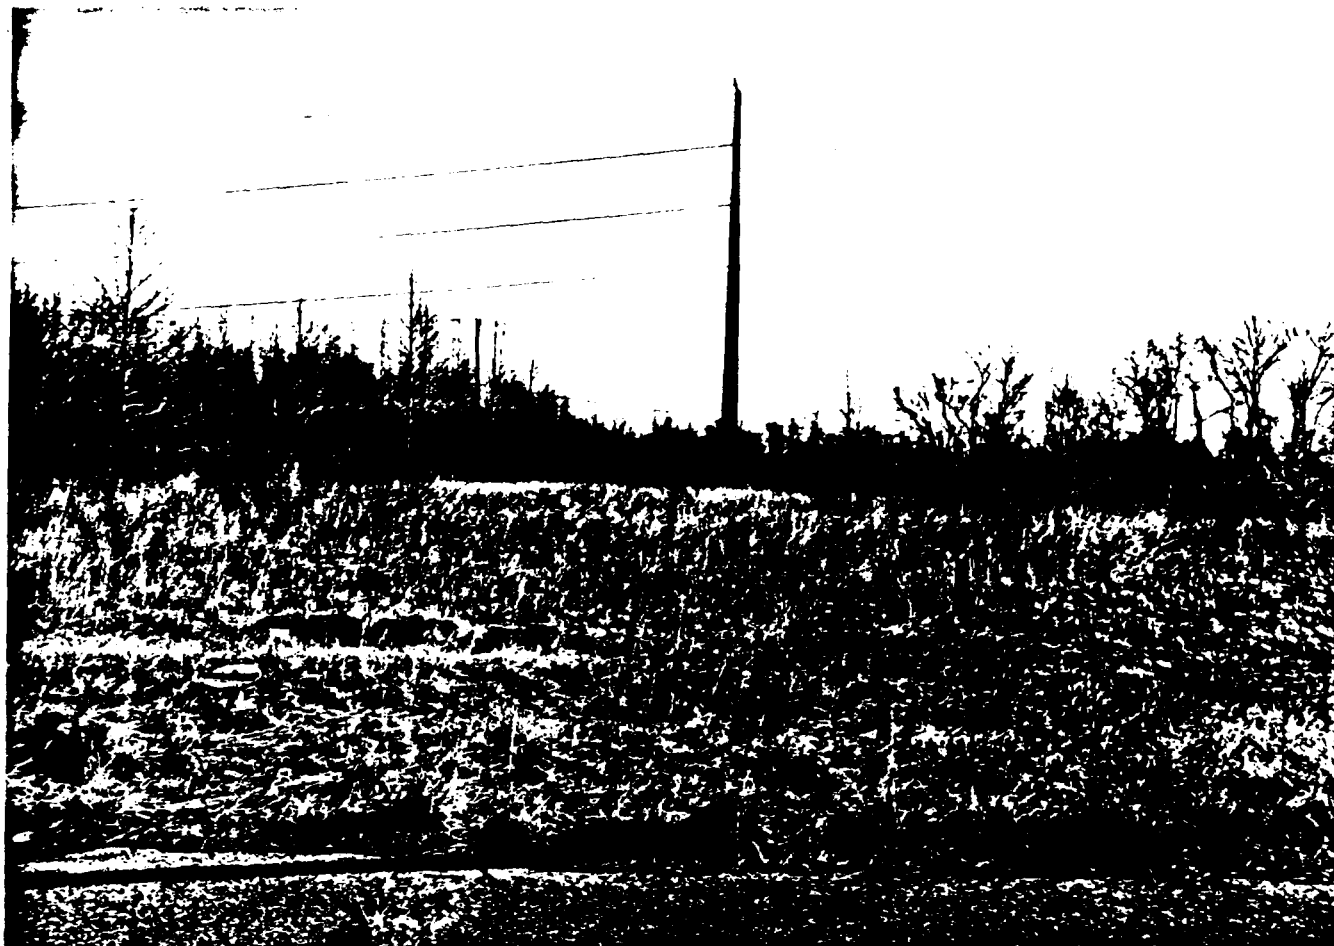
Photo Plate 2:

View looking east at Area 1 from west side of parking lot.
Date: February 10, 1993
Photographer: James M. Harmon

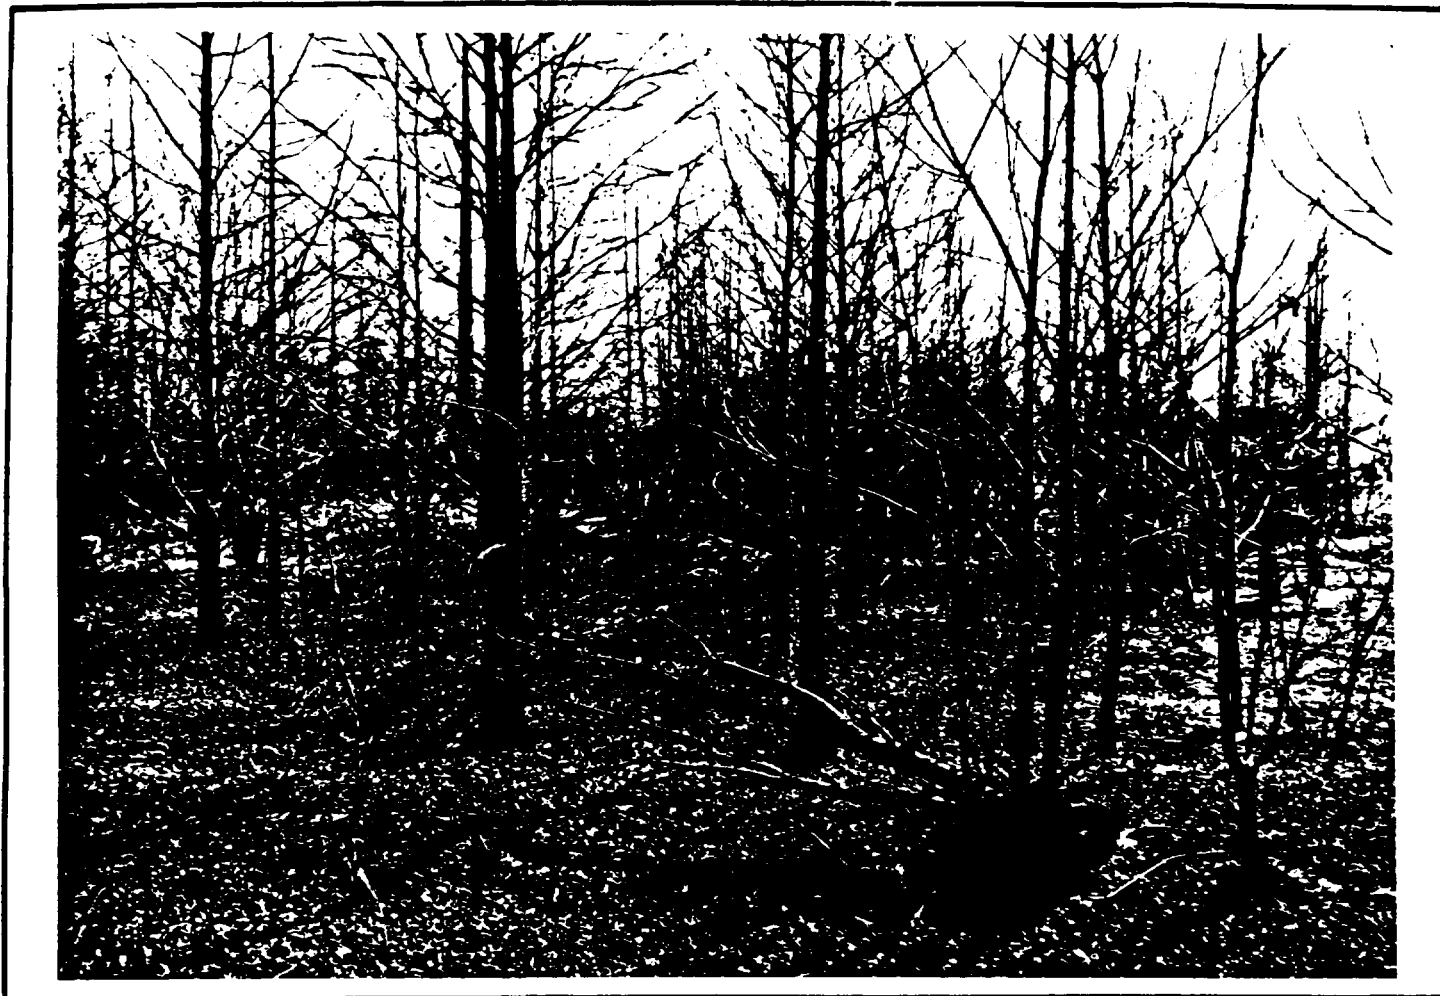
Photo Plate 3:

feet (>.25 acres). It appears probable that the raised area represents a berm of soil formed by grading of the road bed. Sheet wash has removed the majority of the vegetation ground cover in this area (Photo Plate 3).

View looking east at Area 2.
Date: February 10, 1993
Photographer: James M. Harmon

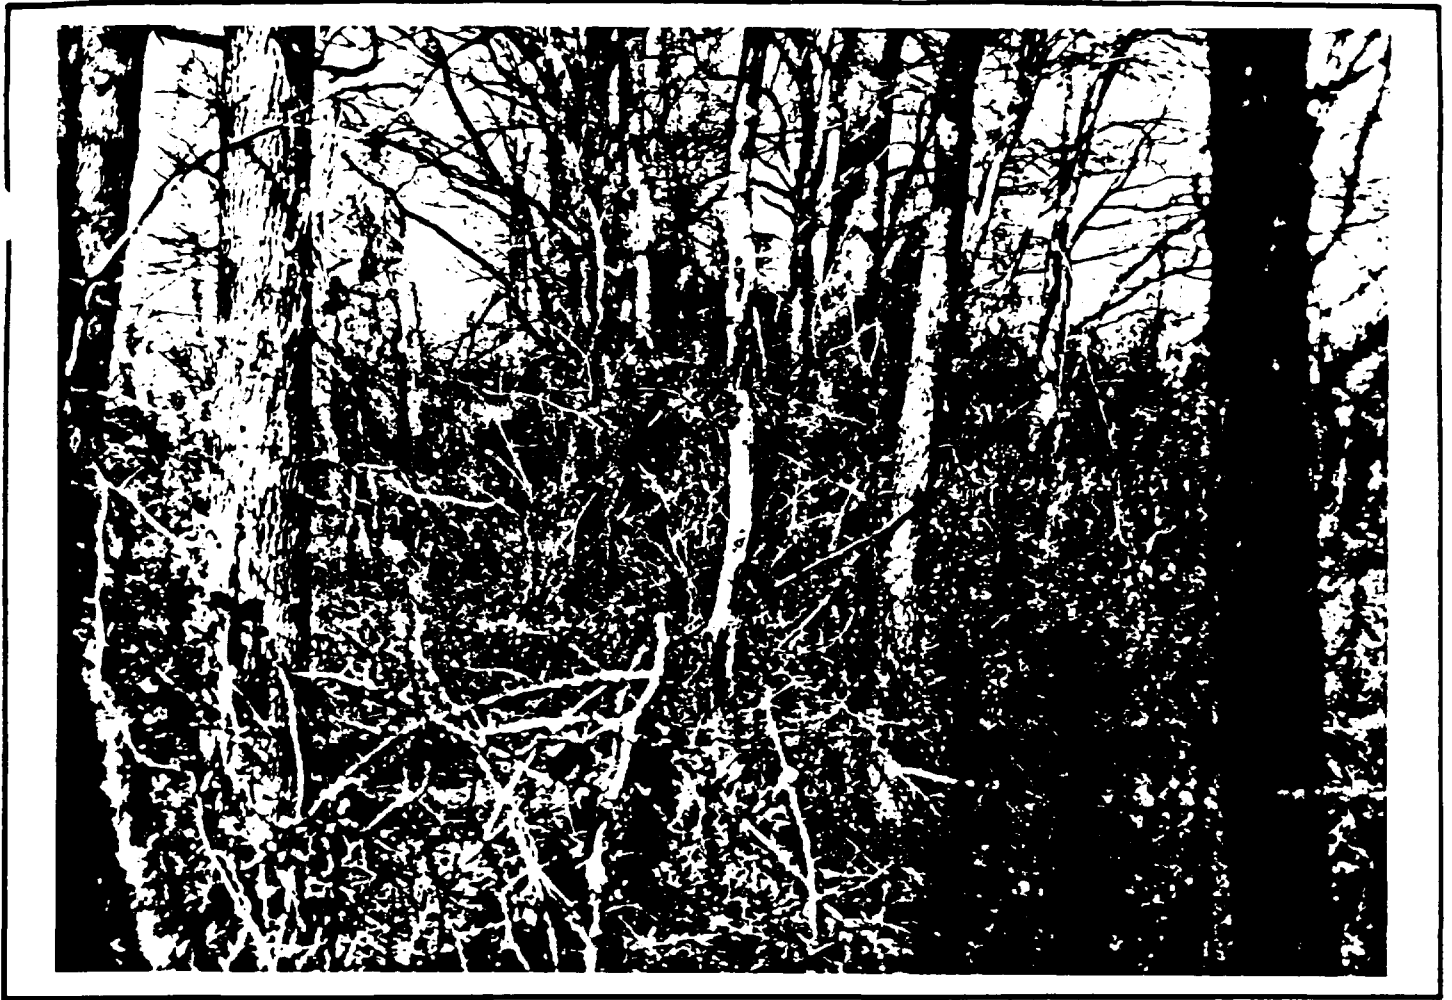
Photo Plate 4:

Area 3 is located immediately adjacent to the eastern edge of the project parcel approximately 1,300 feet north of Area 2 (see base map in back pocket). This area, comprising approximately 9,750 square feet (>.25 acres), is also located entirely within a wetlands zone. Vegetation was very dense within this area of the project parcel, consisting of 1 to 3 foot high undergrowth mixed with larger trees (Photo Plate 4). This condition prevented observation of ground surface disturbance.

View looking north at dense vegetation in Area 3.
Date: February 10, 1993
Photographer: James M. Harmon

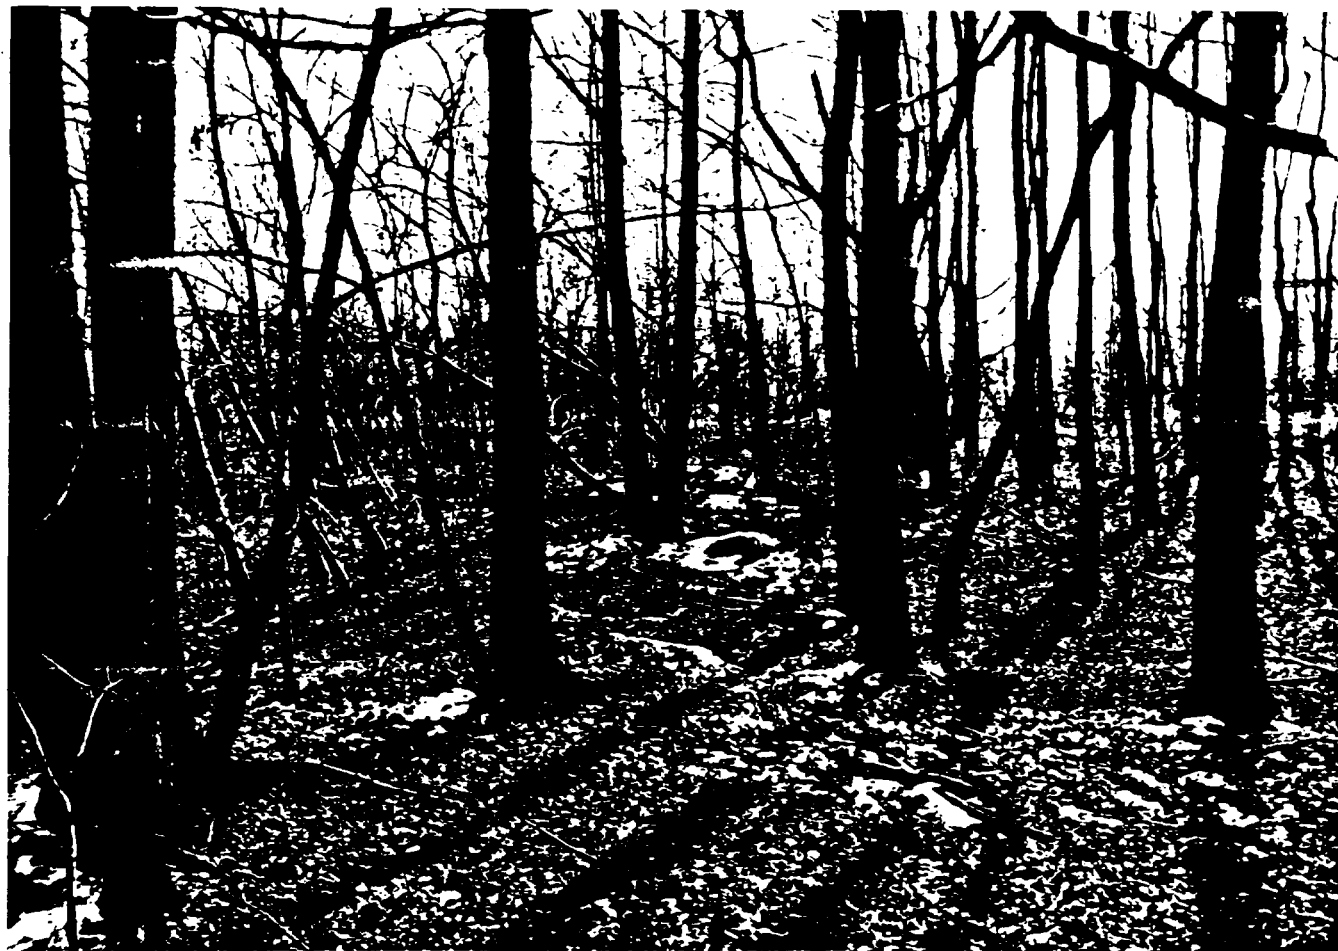
Photo Plate 5:

landform modification by heavy equipment. In addition, numerous automobile tires are present within the area (Photo Plate 5). More recently, suction lines associated with groundwater abatement wells have been installed on a transect through the central portion of the area (Photo Plate 6).

View looking south at Area 4.

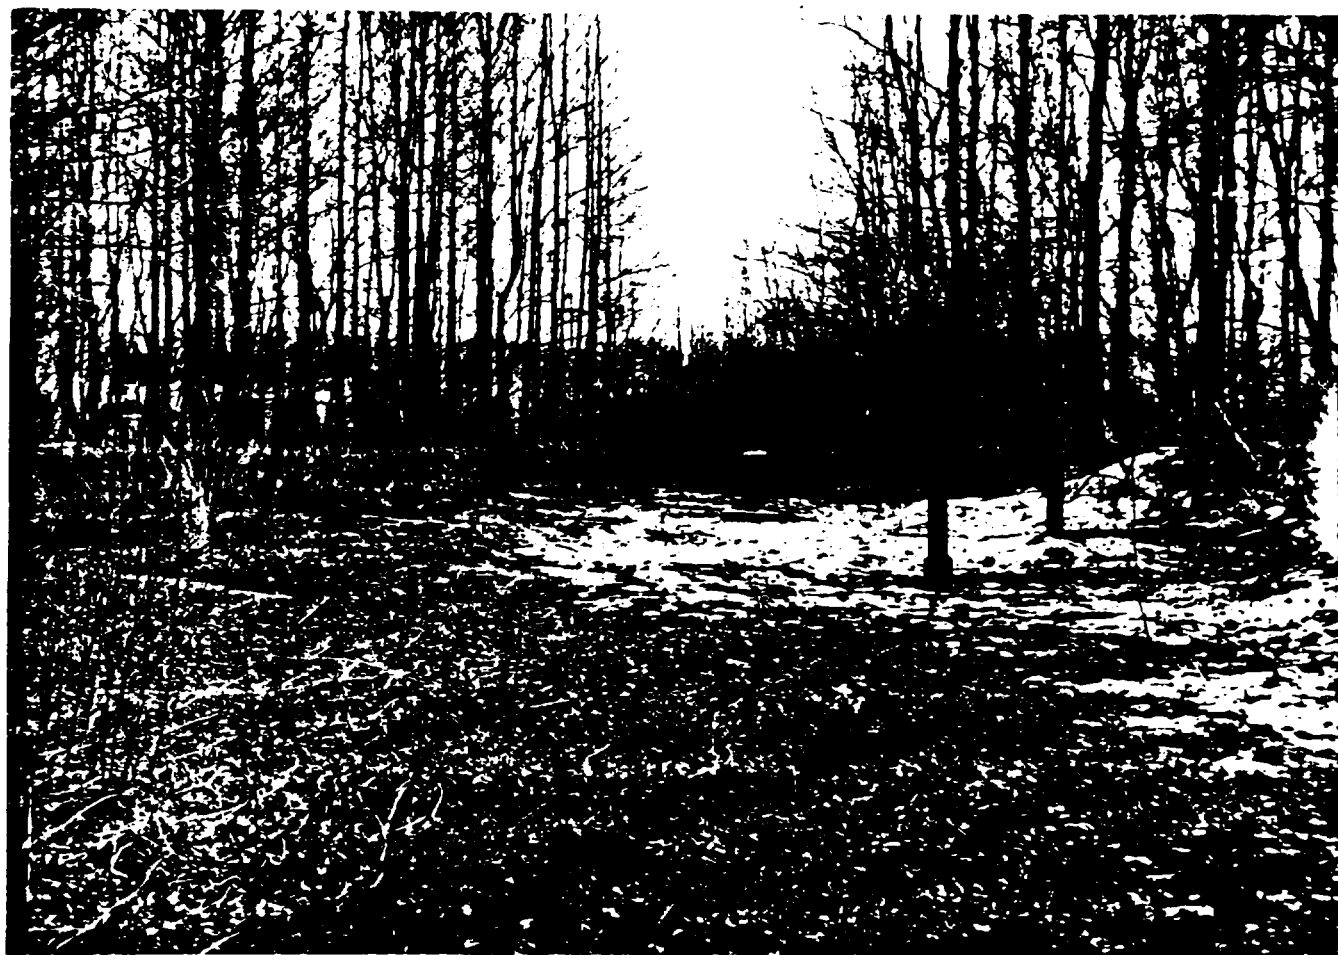
Photo Plate 6:

View looking south/southeast at suction lines in Area 4.
